## BROCKWELL PARK - MARCH 2025

An advisory visit was undertaken to assess the general ground and surface conditions from an agronomic perspective of part of Brockwell Park. The assessment followed the reinstatement works following a major outdoor event, the immediate aftermath of which was reported on in June 2024.

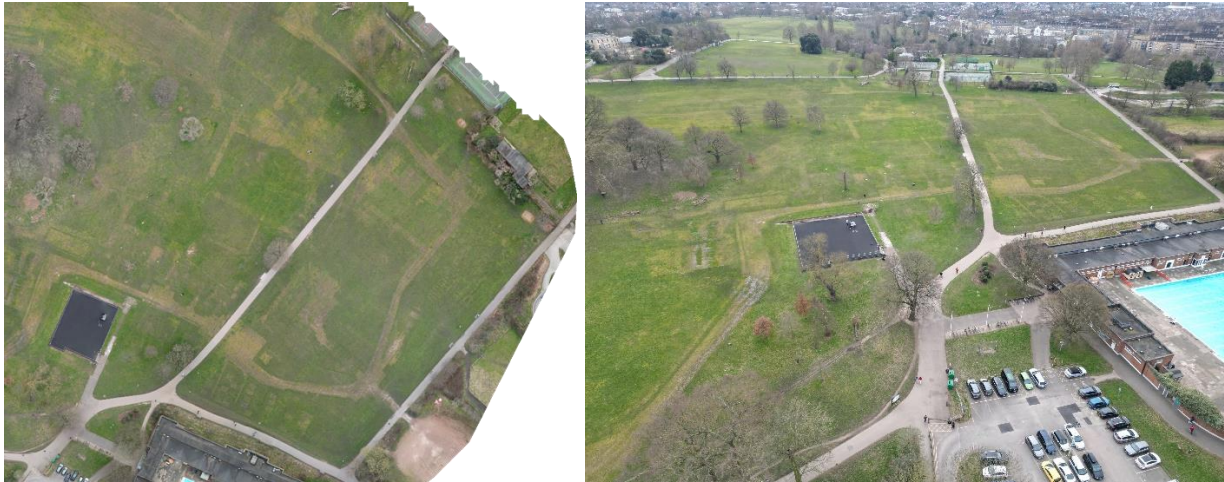
**Figure 2-2 Lido area**

The area to the west I refer to as the Lido area. The pattern of vegetation growth and establishment across this area is indicated in Figure 2-2.

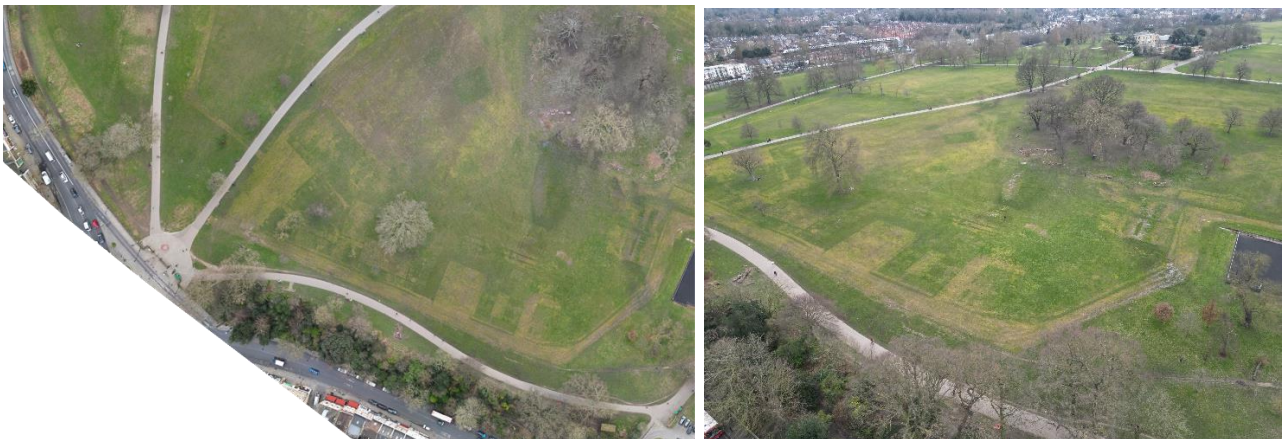
**Figure 2-3 Entrance area**

The Entrance area to the north is shown in Figure 2-3.

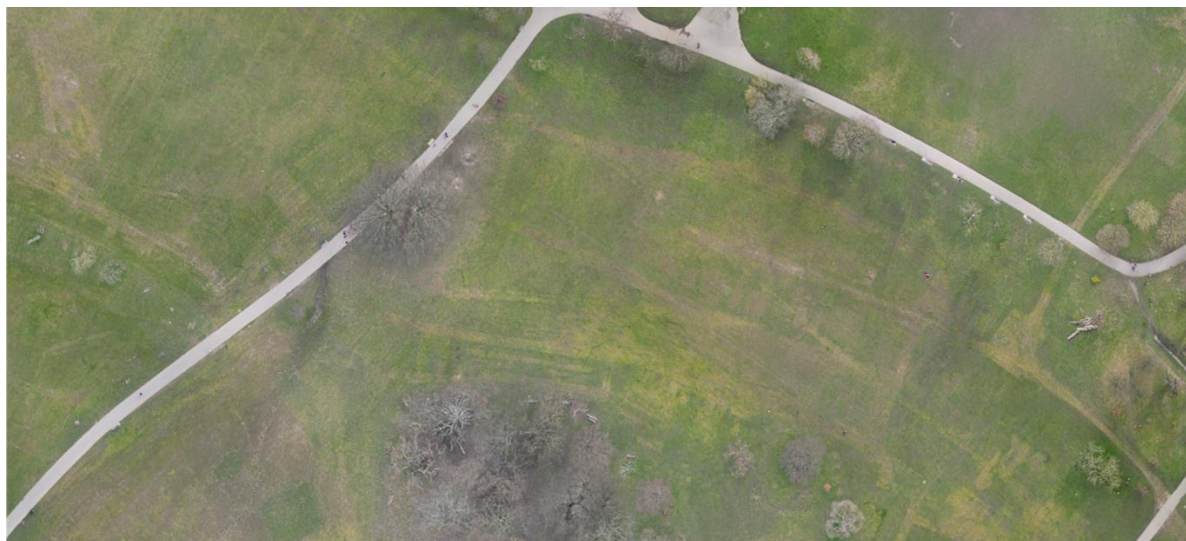
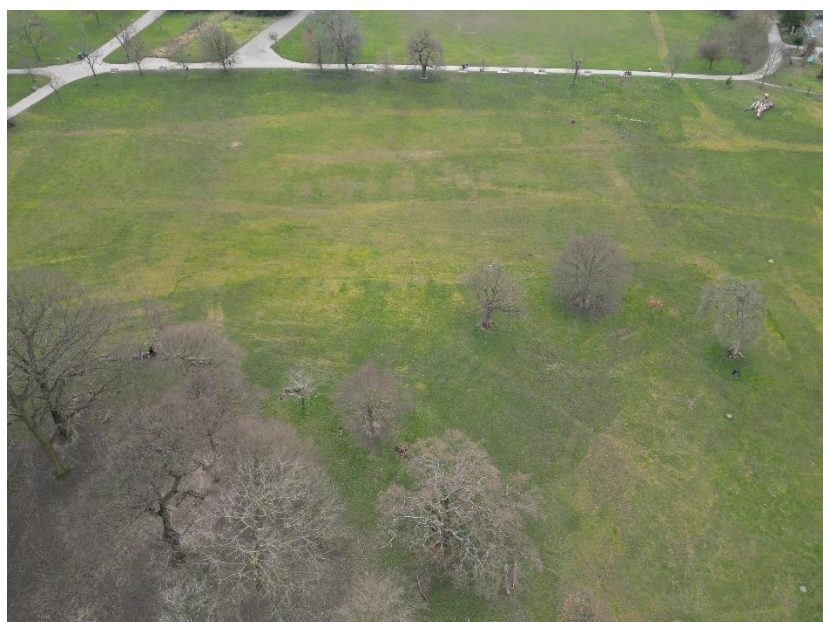
**Figure 2-4 Football area**

The area north of the central woodland I have referred to as the Football area, a football pitch being frequently marked out here (although it was not at the time of the investigation). The aerial image of this area is shown in Figure 2-4.

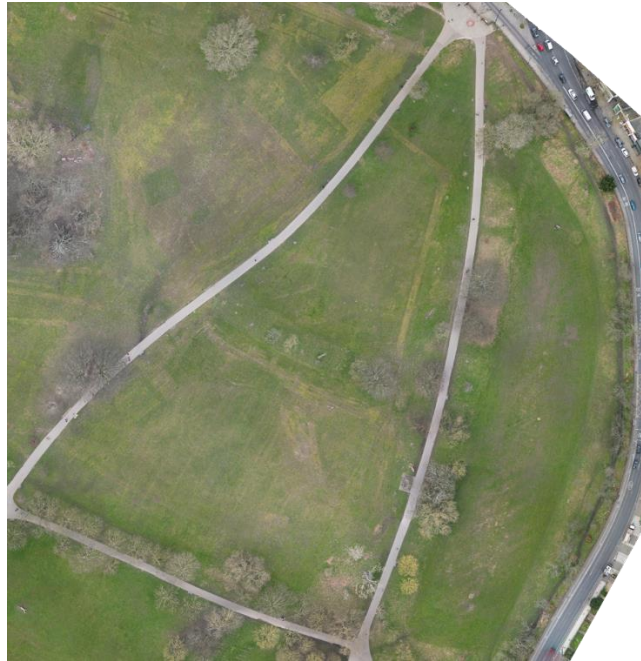
Figure 2-5 Eastern area

The area to the east was not used intensively during the 2024 event but it is to be incorporated into the events proposed for 2025. This area is shown in Figure 2-5.

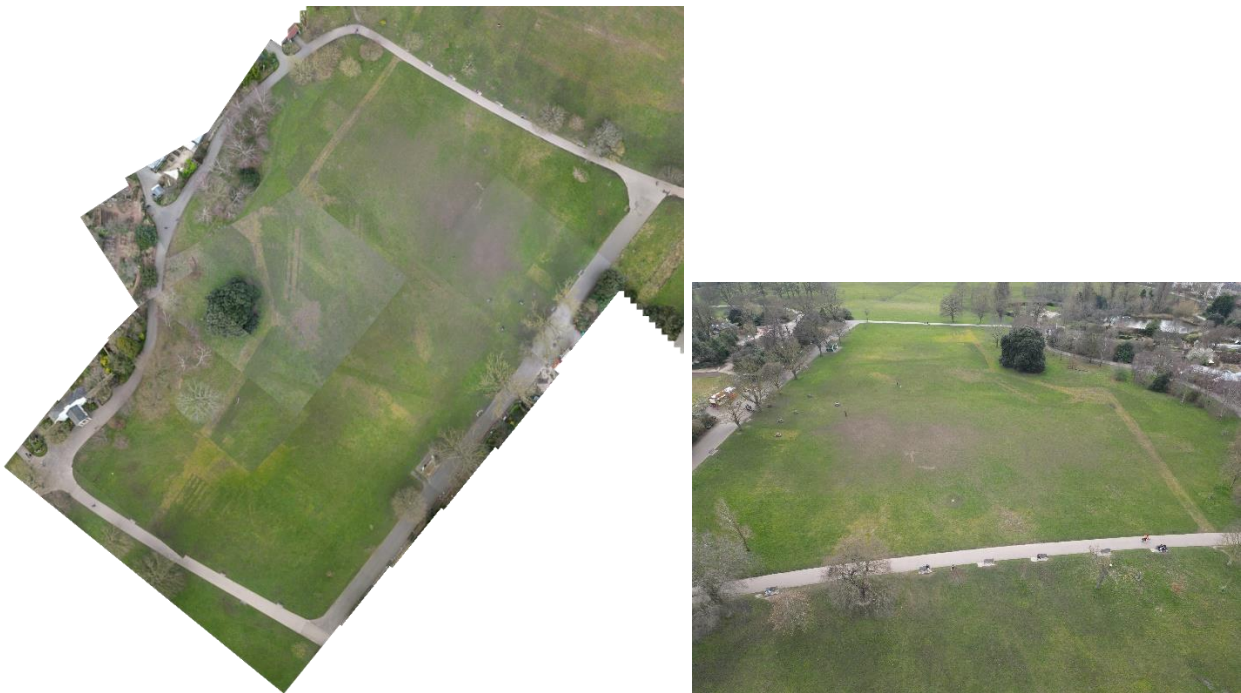
Figure 2-6 South-western area

The south-western area is shown in Figure 2-6. Note that the photogrammetry was less successful than elsewhere for this section on this occasion.

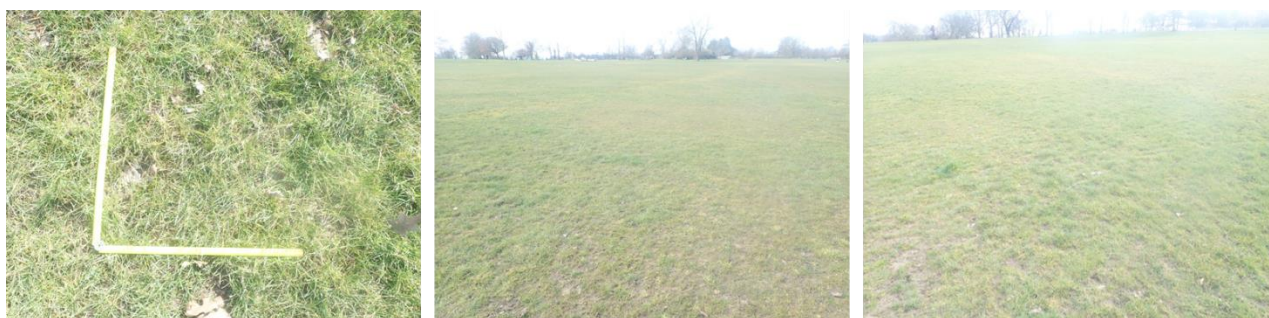
Figure 2-7 Images of Football area ground cover

A reasonably full ground cover had been retained on the football area although a general thinning of the sward was apparent in places.

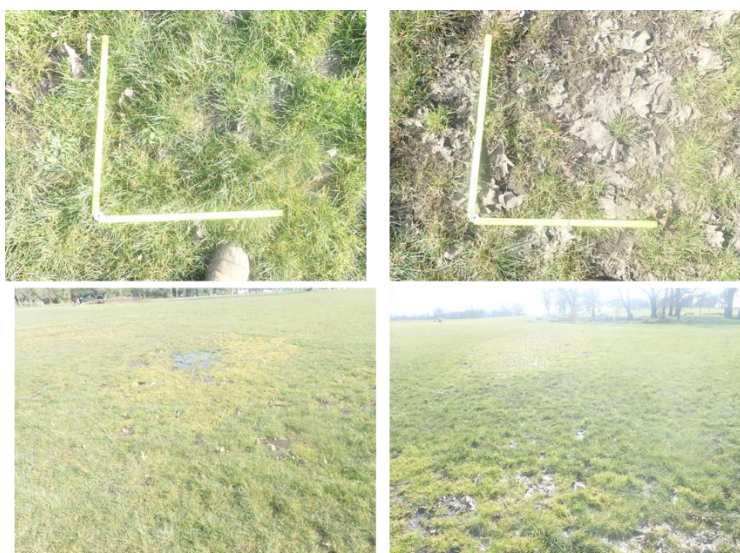
Figure 2-8 Images of the sward in the entrance area

In the entrance area ground cover had been affected by persistent surface water retention. Numerous areas of ponding were apparent at the time of the investigation and it was clear from the sward characteristics that these had been significantly more extensive during the winter period.

Considerable improvement is likely to be achievable by incorporating a catchwater drain along the lower edge of the woodland. This should be as deep as possible, possibly up to 1000 mm, and may be made to discharge into low ground somewhere north of the perimeter track or into an existing surface water collection feature if one can be located. The profile of such a drain is shown in Figure 5-1.

The area itself requires a substantial reconstructive effort to bring it in line with the rest of the park. At around 10 000 m<sup>2</sup>, or 1 hectare, the size of two football pitches, the work involved is by no means unusual in the world of natural turf construction in which similar projects of much larger scale are regularly undertaken.

The procedure would retain all of the useable topsoil, though this would need to be stripped and set aside while the underlying subsoil is graded. With the subsoil surface suitably reformed the topsoil would then be replaced. Into this surface pipe drainage would then need to be incorporated, ideally with laterals at 5 metre centres. The profile of one of one such drain is shown in Figure 5-2.

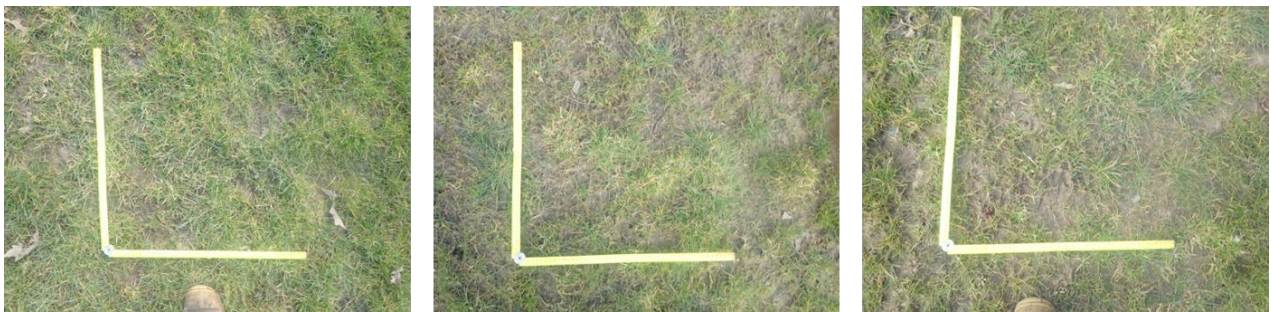
**Figure 2-9 Images of ground cover from the south-western area**

It appeared that the upper section of this area had been used for football or other sporting purposes, either organised or otherwise (there were no line markings present). This had brought about some thinning of the sward although these features were not apparent elsewhere where ground cover was quite substantial.

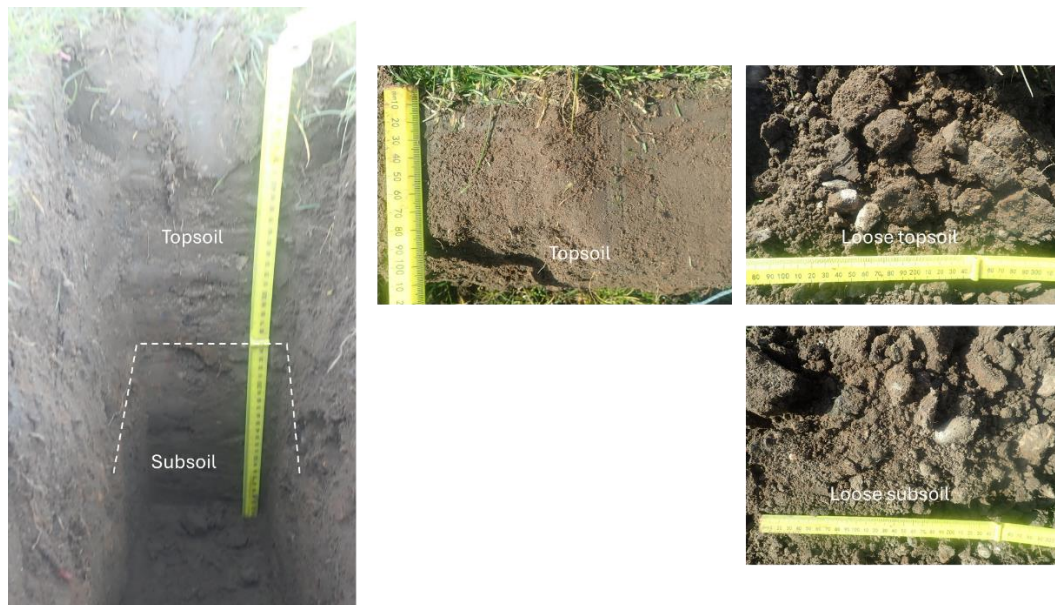
**Figure 3-1 Features of the soil profile of the football area**

Excavation in the football area revealed a topsoil of sandy loam texture that extended to around 250 mm. This became increasingly stony beyond 250 mm.

The subsoil was of a similar sandy loam and contained numerous stones, chiefly in the form of rounded pebbles.

The excavation was made to a depth of 600 mm through which it was fairly dry, no ground or surface water being present.

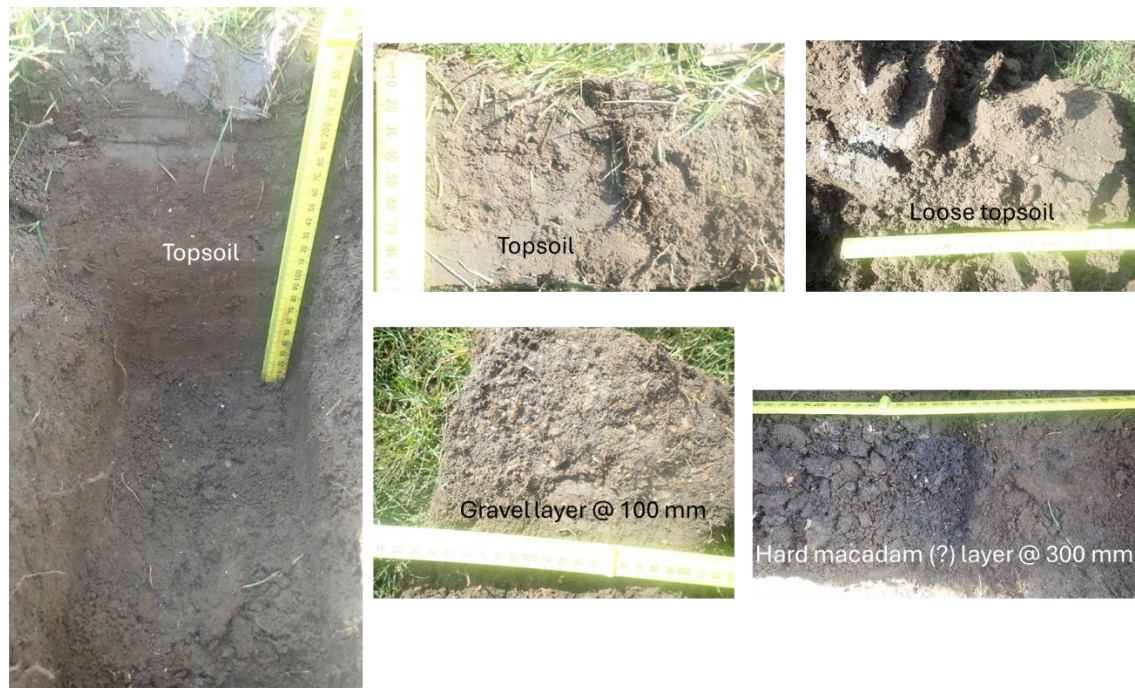
**Figure 3-2 Features of the soil profile of the entrance area**

Two excavations undertaken in the lower, entrance, area indicated that some modifications may have been made to the soil profile over time. The topsoil was generally very hard and stony despite the presence of extensive surface water over the area. What may have been a gravel layer was encountered at around 100 mm. This was causing a distinct break in the depth of grass roots that was achievable. Excavation by hand was impossible beyond around 200 mm due to the presence of a very stony, possibly old macadam, layer.

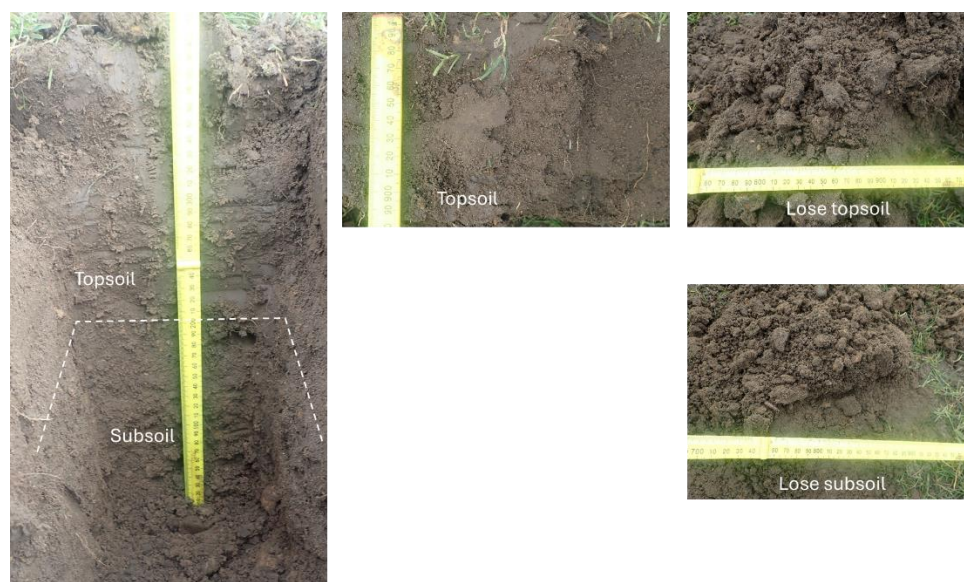
**Figure 3-3 Features of the soil profile of the south-western area**

A soil profile essentially similar to that of the Football area was encountered in the south-western area. Here a sandy loam topsoil extended to around 250 mm with a slightly finer and possibly greater clay content in the subsoil beyond this. An increasing quantity of stones were encountered at around 350 mm.

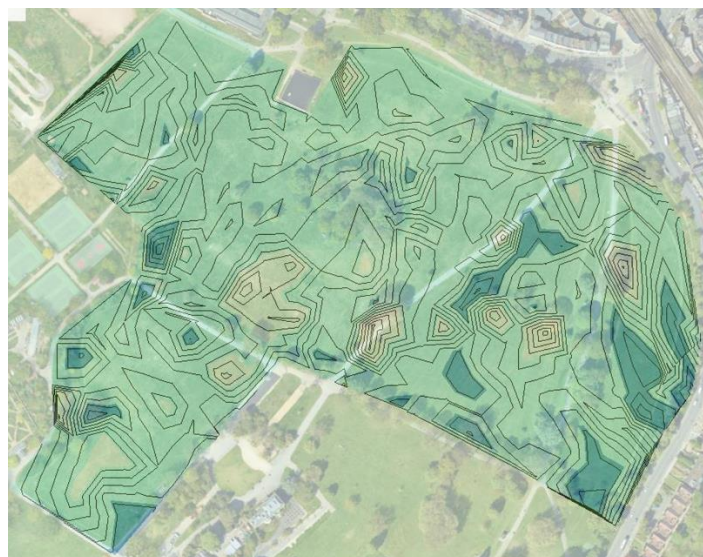
**Figure 3-5 VMC contours on Google Earth image of site. Areas over 50 % shaded**

The areas of VMC greater than 50 % are shown shaded in Figure 3-5.
