## BROCKWELL PARK

### **Agrostis Sports Surface Consulting**

01 June 2023

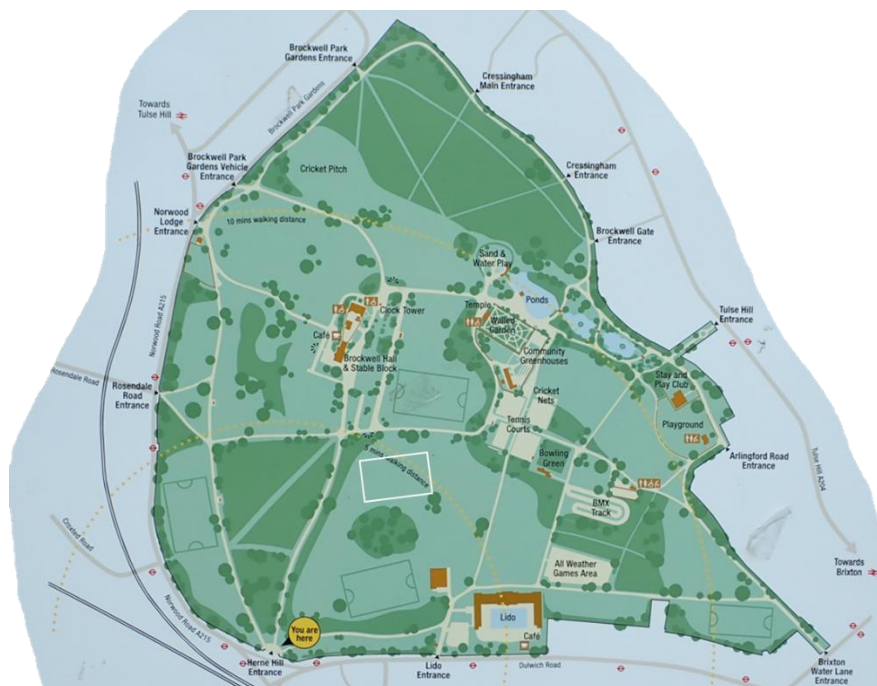
**Figure 1-1 Plan of the site**

The site was visited on 17 May 2023. A plan of the site is provided in Figure 1-1 for reference.

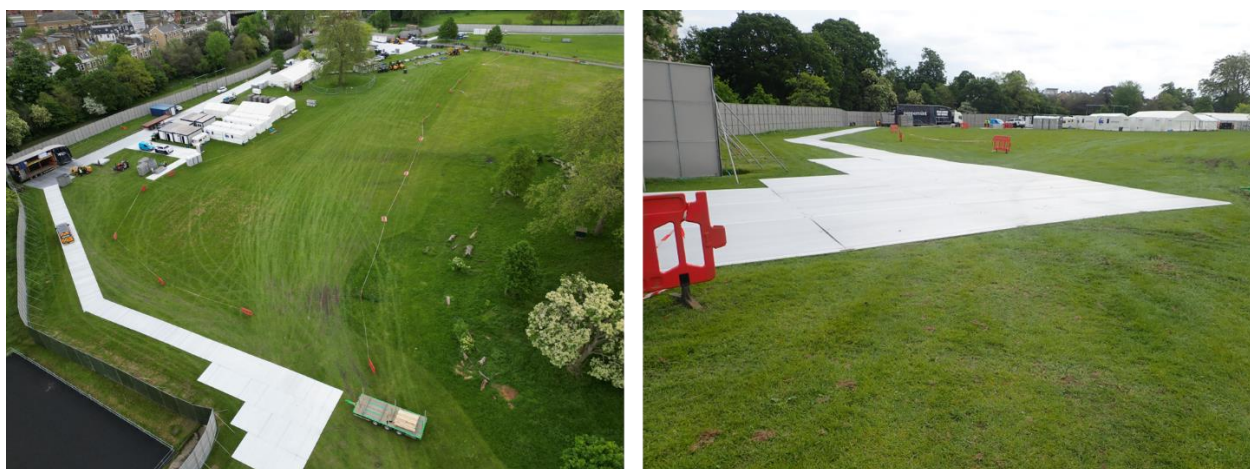
At the time of the visit an event was being installed and approximately 50% of the perimeter fencing had been put in place. A good deal of trackway had also been incorporated.

**Figure 1-2 Trackway, installations and fencing being installed in Red Gate area**

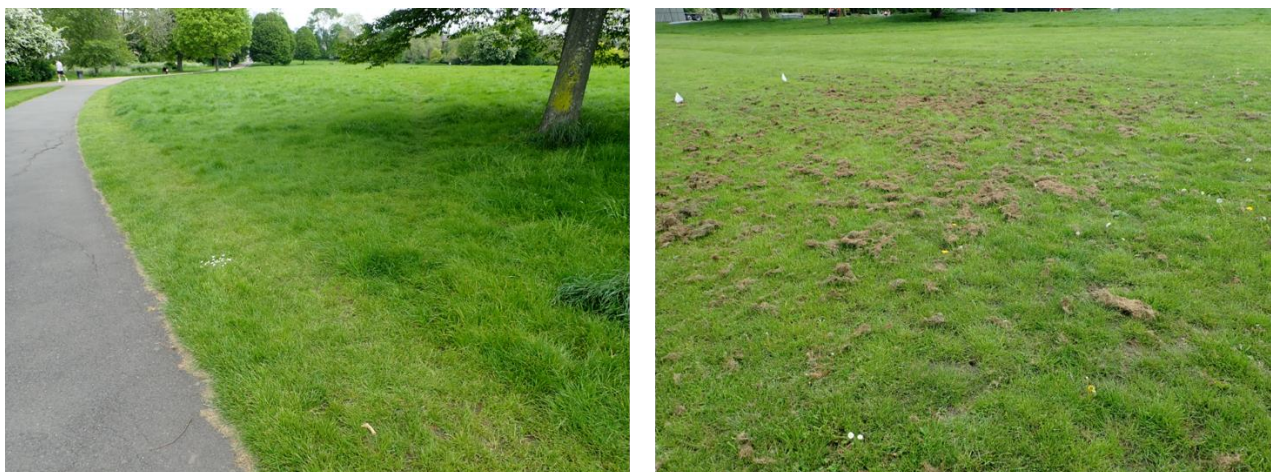
Grass growth across the park at the time of the visit was generally vigorous. This was indicated in part by the profusion of grass clumps in the surface following a recent mowing operation and the generally taller and dense vegetation in particular around trees and in the perimeters.

**Figure 1-3 Vigorous growth in perimeters and an area of profuse grass clippings**

The land as a whole should, therefore, be maintained in the manner of pasture, the mower replicating as far as possible the grazing of animals such as sheep and deer. This contrasts with the circumstances at Clapham Common where a meadow vegetation should be aspired to.

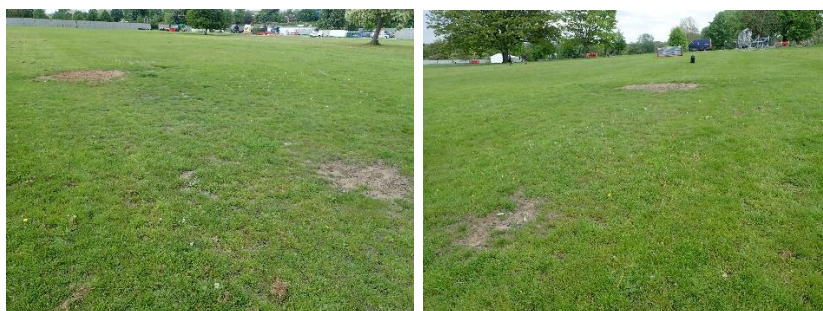
On the football pitch in the southern field (white outline in Figure 1-1) only the goalmouth and the football pitch showed significant ground cover losses with typical patches of bare ground about 1 metre across.

**Figure 1-4 Eastern and western goal mouth areas of football pitch**

It was noted that the football pitch had been verti-drained at some point during the early spring. This will be beneficial and will further increase its resilience in relation to usage. However, the pitch is sloping across the direction of play by a substantial degree. Its development as anything other than a casual playing surface would therefore require much more substantial earthworks to be undertaken.

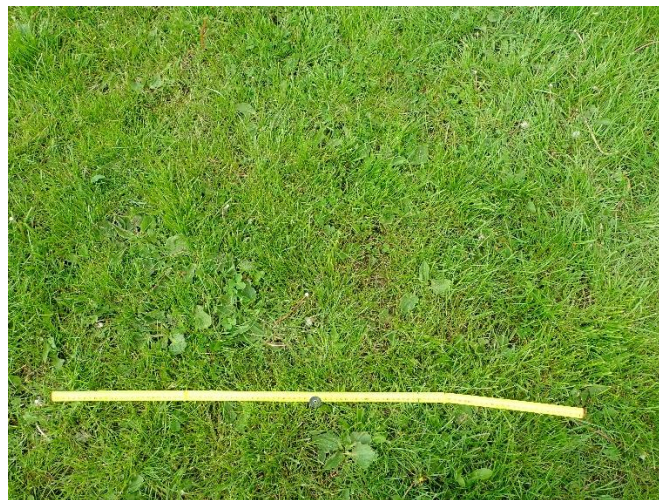
Over such a large area and diversity of species is inevitable, but the main grass component of the sward was typically perennial ryegrass. This grew in a dense and vigorous fashion in almost all areas. Sward height at the time the visit in areas obviously subject to mowing was around 75 to 100 mm. Few other grass species were noted amongst the perennial ryegrass. Broadleaf species included plantain and dandelion which were frequent.

**Figure 1-6 Typical appearance of the sward in un-renovated area**
